# Manhole Inspection Summary

Manhole # S19I1\_024MH

Insp Date: **4/22/08 12:19 PM**

**Location** Address: **3036 huron st**

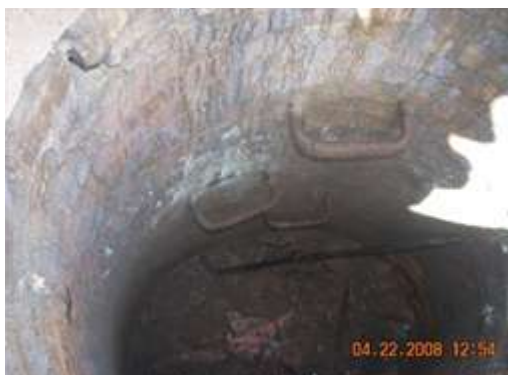
Defect 2

Count: **3** Missing: **0** ☒ **Corroded**

corroded steps

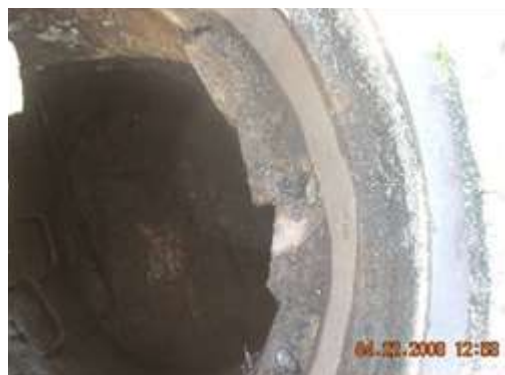
Defect 1

Offset: **2** (in.)

frame offset

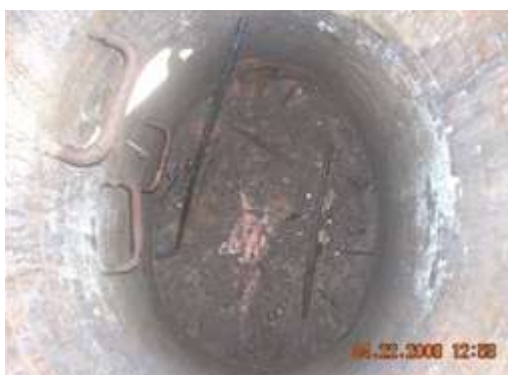
Defect 3

Condition: ☐ Sound ☐ Cracked ☐ Root Intrusion ☐ Deteriorated ☐ Leaks ☒ **Debris**

channel cond debris
